CONFIDENTIAL REPORT

Inspected Property: 41 Anyplace St.
Centerville, NJ
Frame Townhouse Unit

Inspector: Ronald Testa

Date of Inspection: Anytime, 2014

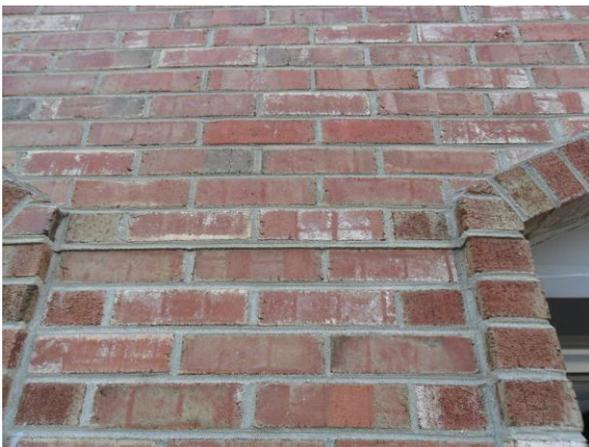
Figure 1

Aluminum and brick siding was noted. The brick siding has settled excessively with gaps in brickwork in areas including above and between this and adjacent unit garage doors (Fig 1) and to the right side of the garage door opening (Fig 2). Also, at the siding extension and stanchion brickwork is loose (Fig 3). Have a licensed professional that specializes in the functional area perform repairs.

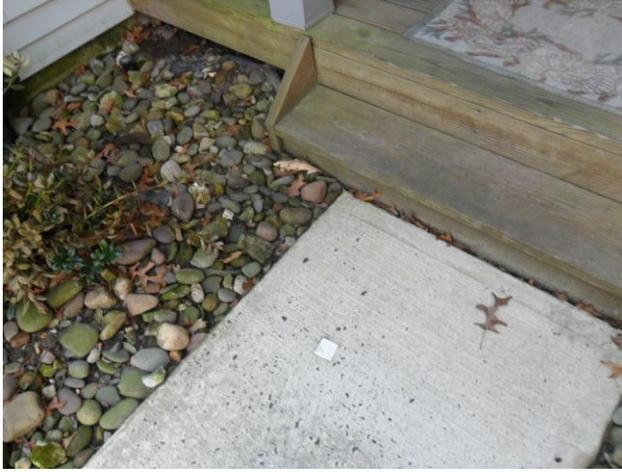
Figure 4

The wood step at the front is in marginal overall condition. The side stringer members are loose. Riser height varies excessively, creating a tripping hazard. Repair. (Fig 4). The wood porch area, largely exposed to the weather, is weathering and wearing.

The concrete walks appeared to have settled moderately. Note that a plumbing clean out cover has been embedded in the concrete of the front walk (Fig 4). We recommend that access be recreated such that access to the clean out can be obtained in the event of a clog.

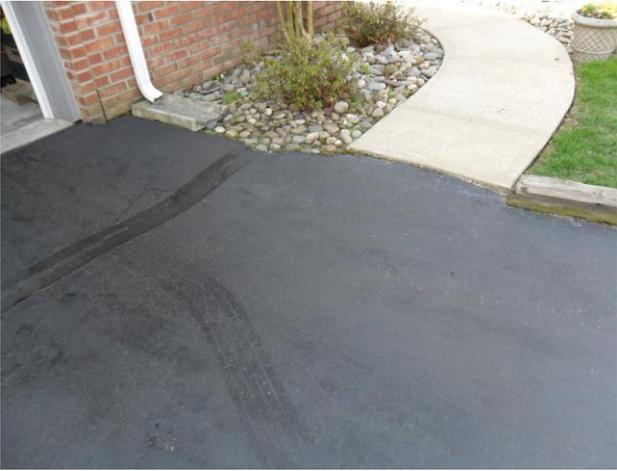
Figure 5

The asphalt driveway has settled, created tripping hazards at the walk (Fig. 5) and where the driveway meets the curb area. Correct, for pedestrian safety. A temporary type repair in the form of a covering membrane type material has been applied near the driveway (Fig 5). This is a temporary type repair and may loosen in time. Improve, as needed. The periodic application of a sealant may help extend the service life of the driveway. The ties at the driveway perimeter are decaying. Replacement of decayed/damaged components is suggested. Note that wood ties are slippery when wet. Consider use of a masonry type border and removal of the border.

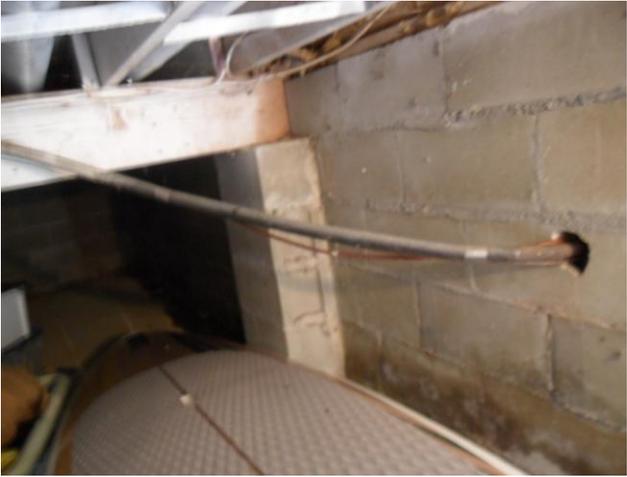
Figure 6

Where minimally visible, floor joists are in satisfactory overall condition. Where visible, the girder is in satisfactory condition, except as noted. Where wood members are supported by masonry components, a metal plate is normally present to help prevent moisture travel from the masonry to the wood material. We recommend installing, as feasible. The wood framing and floor sheathing has been painted white (Fig. 6) This was likely performed to help control mold growth on the wood components and is a likely sign that elevated moisture exists in the crawl space. Check with the association and current owner on specifics. We also recommend that you consider having a mold evaluation due to the painting and signs of possible mold growth in areas including on the rear wall area (Fig 6).

Signs of likely mold growth were noted, including at crawl space walls and floor areas. We recommend testing and implementing measures to remove and control mold growth. Consult with a licensed professional that specializes in the functional area.

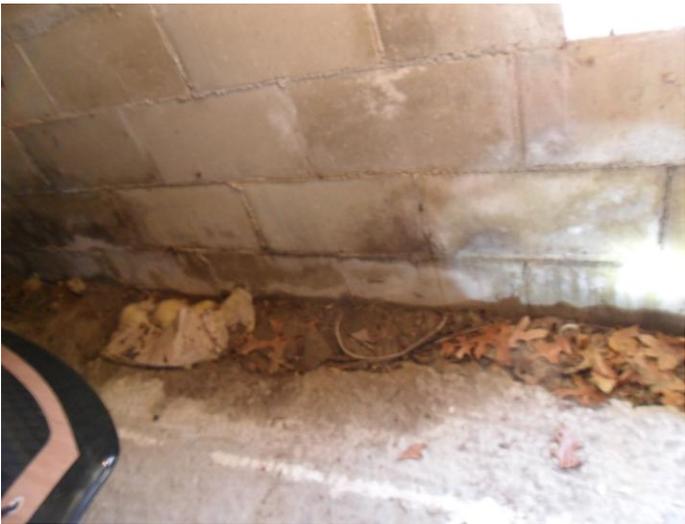
Figure 7

The crawl space was damp at the time of the inspection. Signs of past water penetration were indicated by water marks at the walls and floor in many areas (Figs 7). The current owner indicated that he has not experienced prior water entry into the crawl space. As also shown in Figure 7, the perimeter section at all sides have been broken away, likely to help reduce water collection in the crawl space. It appears that the idea is for water to drain into the soil at the perimeter. Note that this action is not to the standards of the trade. Normally, a perimeter drain system below floor level is installed, covered with concrete and system drained to a sump pit with pump. We recommend that you have a licensed professional that specializes in the functional area perform a full evaluation to determine full corrective action.

Note that the degree of future water penetration is not determinable by this inspection. Based upon our observations, additional water control measures, such as installation of a perimeter drain to collect water entering should be considered. We recommend that you have a licensed professional that specializes in the functional area perform a full evaluation for a determination of water control measures required.
