## **CONFIDENTIAL REPORT**

Inspected Property: 41 Anyplace St.  
Centerville, NJ  
Frame Townhouse Unit

Date of Inspection: Anytime, 2014

### **INTRODUCTION**

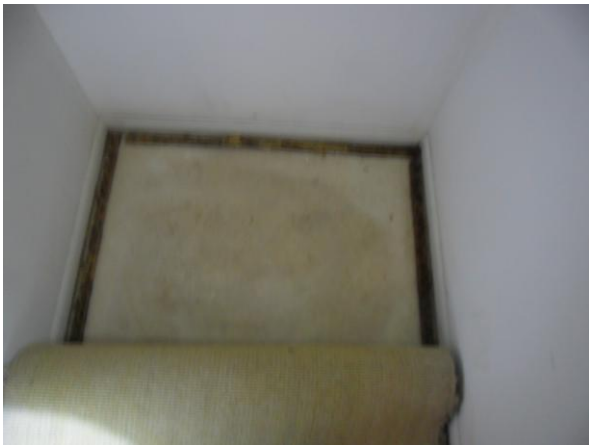
Figure 3

The basement was damp at the time of the inspection. Signs of past water penetration were indicated by water marks at the walls and floor in many areas (Figs. 3,4,6,7). Water was observed at the wall/floor interface at the right side wall, toward the rear. The current owner was not present to ask about current and prior water entry into the building. We recommend that he be asked.

Note that the degree of future water penetration is not determinable by this inspection. Improving the grading to help direct the water, as feasible and as previously discussed, may help to reduce water entry into the building. Based upon our observations, additional water control measures, such as installation of a perimeter drain to collect water entering, including that from holes drilled in the walls, will be required to address water issues. We recommend that you have a licensed professional that specializes in the functional area perform a full evaluation for a determination of water control measures required.

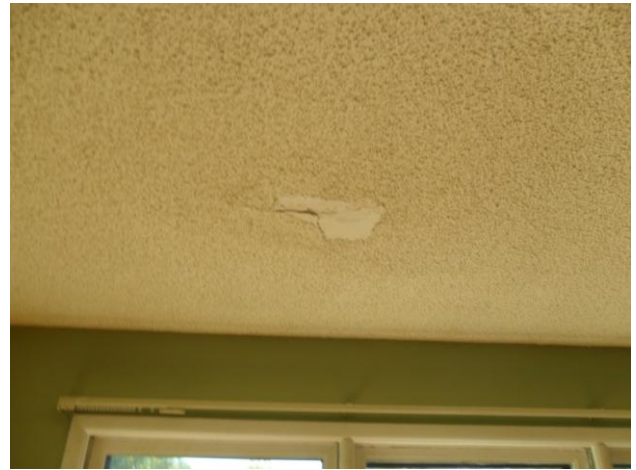
Figure 8

The walls and ceilings are in satisfactory overall condition, except as noted. At the front of the living room (Fig. 8), damage at the ceiling was observed, likely due to water leakage. After determining and correcting cause of leakage, we recommend that interior ceiling components be checked when repairing. We also recommend removal of the rug and examination of the floor and supporting members at the upper level also due to loose flooring and settlement of the flooring in this area, possibly caused by water damage.
