CONFIDENTIAL REPORT

Inspected Property: 41 Anyplace St.
Centerville, NJ
Frame Townhouse Unit

Inspector: Ronald Testa

Date of Inspection: Anytime, 2014

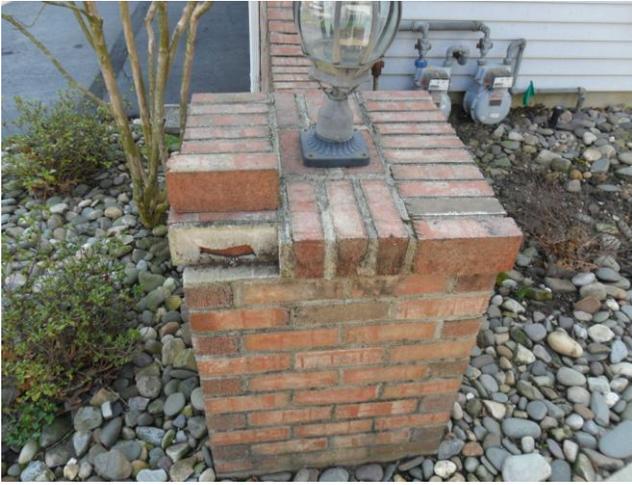
Figure 2

Aluminum and brick siding was noted. The brick siding has settled excessively with gaps in brickwork in areas including above and between this and adjacent unit garage doors (Fig 1) and to the right side of the garage door opening (Fig 2). Also, at the siding extension and stanchion brickwork is loose (Fig 3). Have a licensed professional that specializes in the functional area perform repairs.
